## Fairmount Park Concourse Lake

**Location:** Philadelphia, Pennsylvania

**Client:** Fairmount Park with Garden Club of

**Status:** Conceptual plans implemented 2012

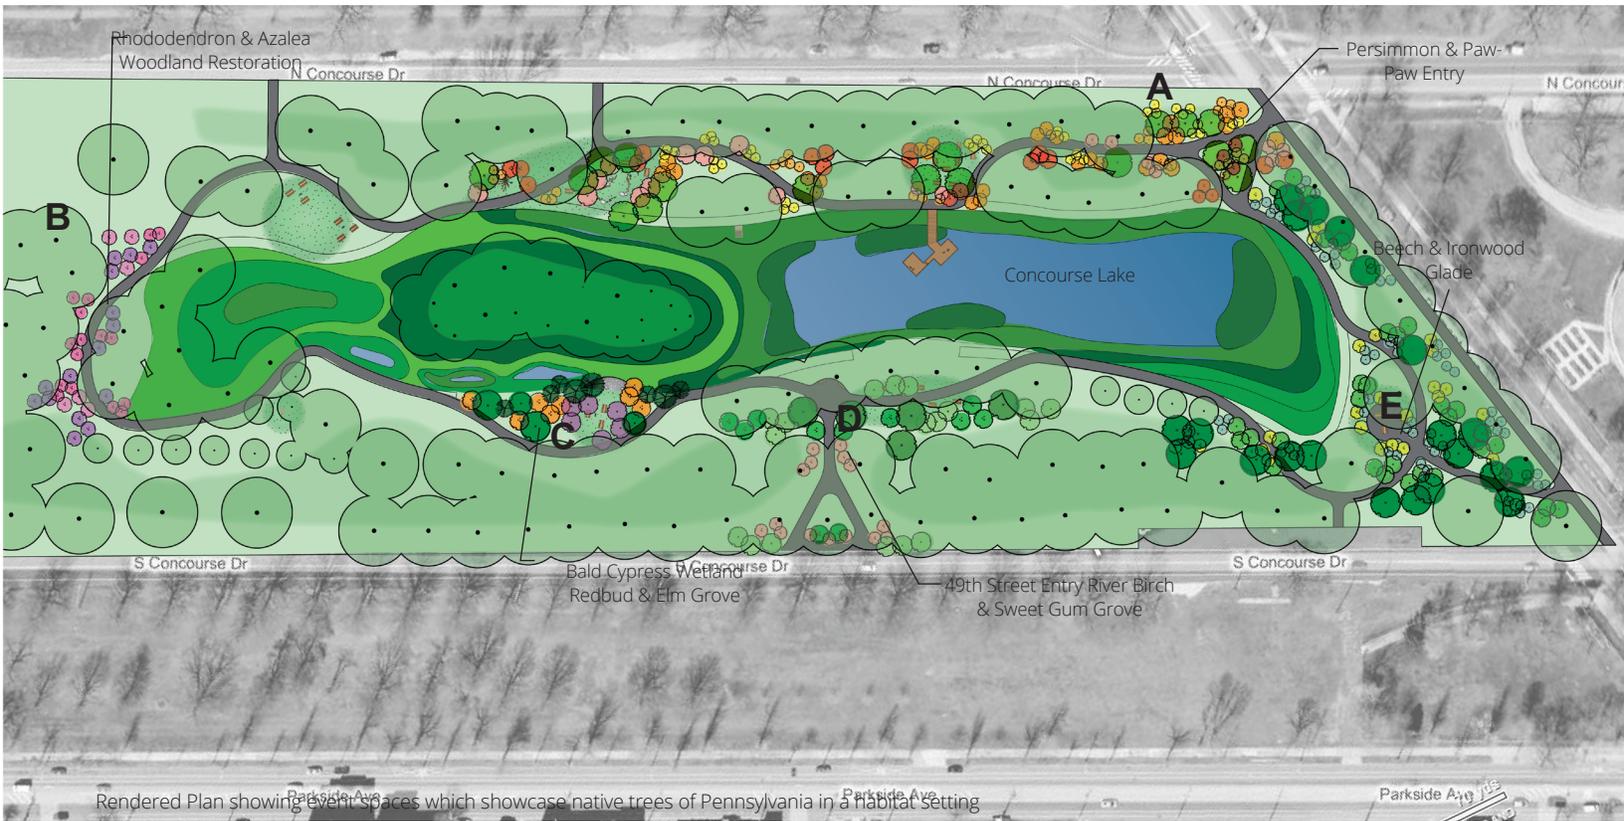
The restoration of Concourse Lake showcases Pennsylvania's native trees within habitat settings thus moving away from a conventional arboretum approach that showcases individual specimen trees. Trees are arranged not in the formal rows and lines of days gone by, but rather planted to showcase the seeding and spreading habits of the various trees. This approach fosters an appreciation of our forested landscapes which once covered 99% of the eastern United States, supporting a healthy hydrologic cycle. It creates dynamic zones of varied atmosphere that feel complete after the initial planting. The project builds upon the existing landscape zones and planting can be elaborated on over time to include shrubs, grasses and ground covers thus completing each mini-forest ecosystem.

Each zone includes a different type of gathering place for people from large scale picnic groves to intimate teaching areas. The zones are interconnected by a path that weaves in and out, toward and away from Concourse Lake.

A. Belmont - North Concourse Entrance Persimmon and Paw-Paw Entrance Walk: These colorful fruit-bearing trees are planted in little copses. Once the tree reach fruit-bearing age, children can harvest the staples of early American

diet and make their own pies and preserves.

B. Rhododendron and Azalea Woodland Restoration: Native azaleas and rhododendron interplanted amongst the mature trees and shrubs enrich this mini-woodland by adding seasonal color and texture.

C. Bald Cypress Wetland/ Redbud and Elm Grove: Additional Cypress trees build upon the restoration of Concourse Lake into a working wetland and pond. These trees are planted in pure multi-aged groves to replicate the feel of an ancient Cypress swamp.

D. 49th Street Entrance: Sweet Gum Grove: Sweet Gums often propagate via their roots and form amazing clumps and groves in nature. Here the trees are planted to mimic those patterns and form a stunning multi-age gateway for the neighborhood.

E. Belmont - South Concourse Entrance - Beech and Ironwood Glade: The center point of this new landscape is an existing Ironwood. This tree, once attended to by a qualified arborist, will be stunning.
